Wempley Public School

2004 – CJ+P completed an exterior brick repair project of the south side of existing school;

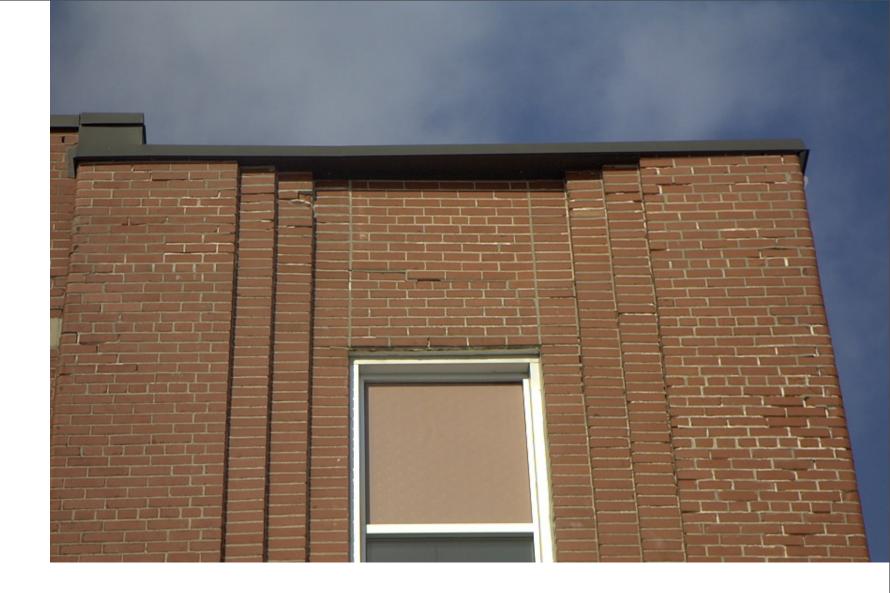
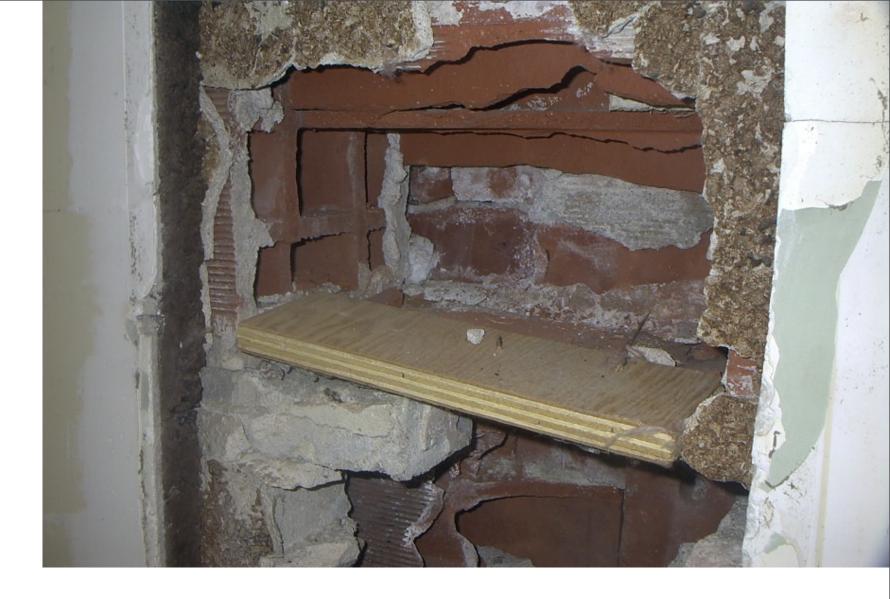
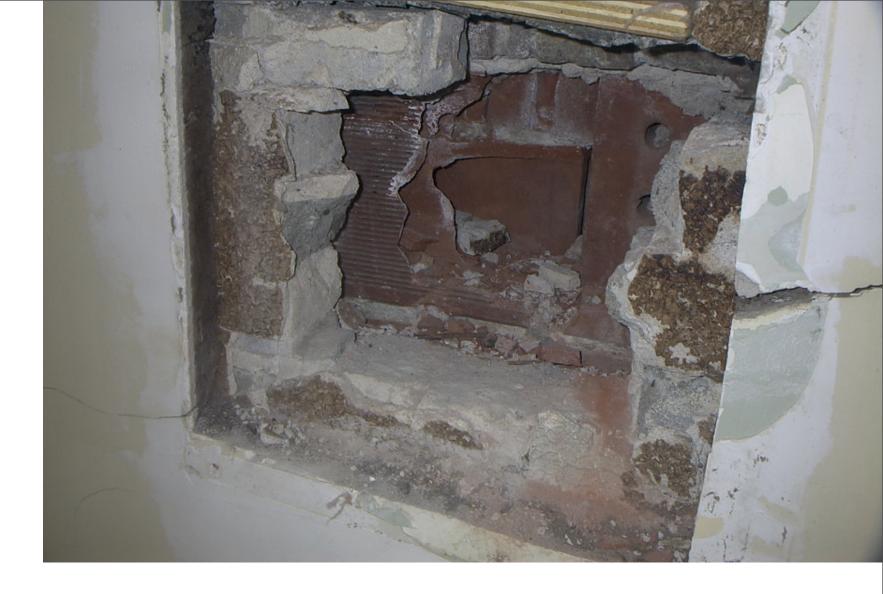
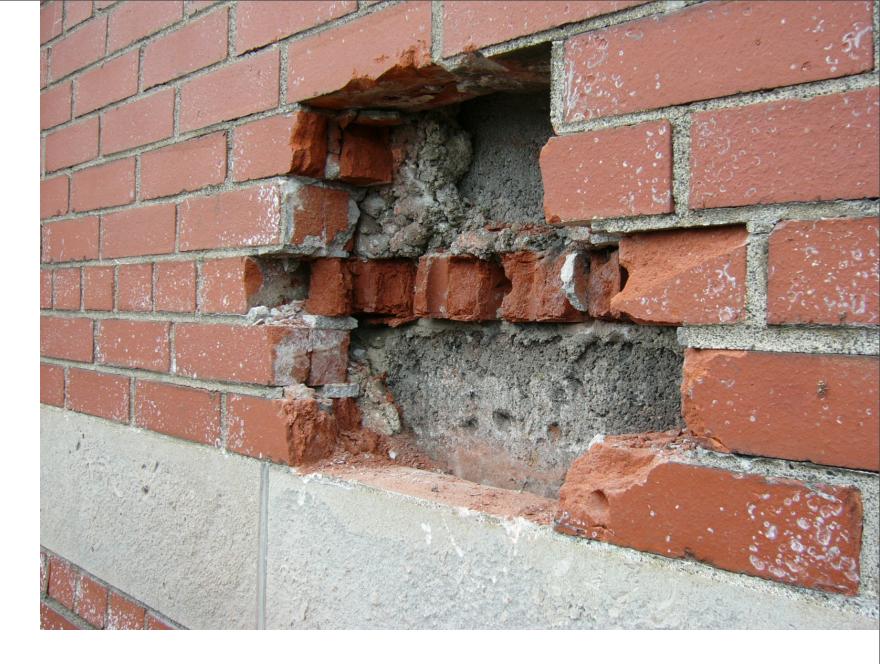
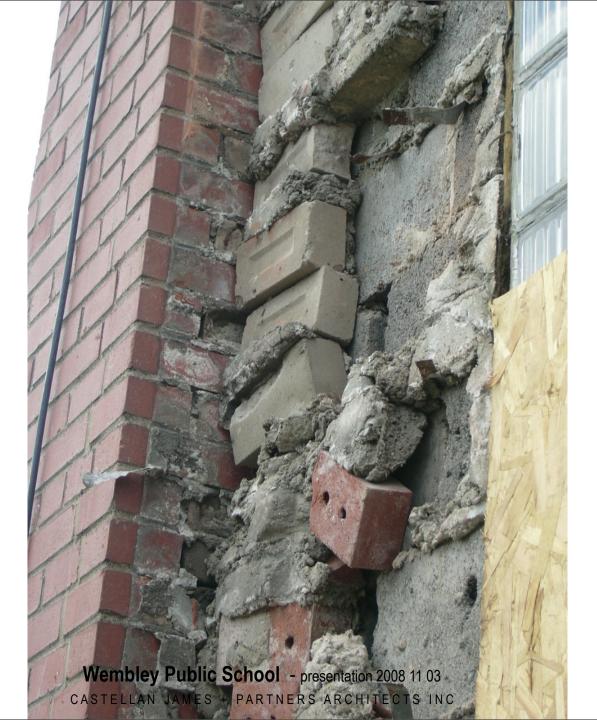
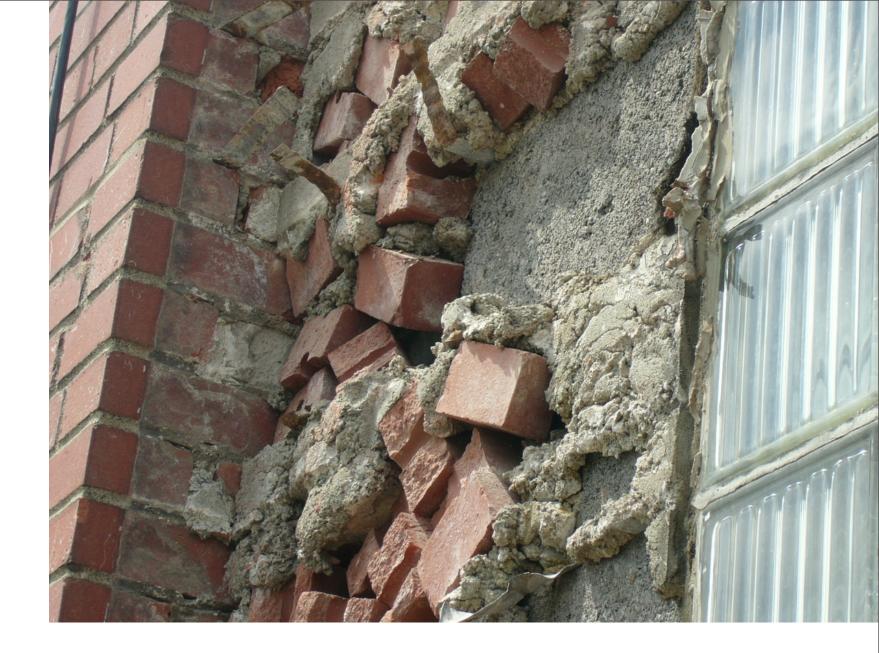
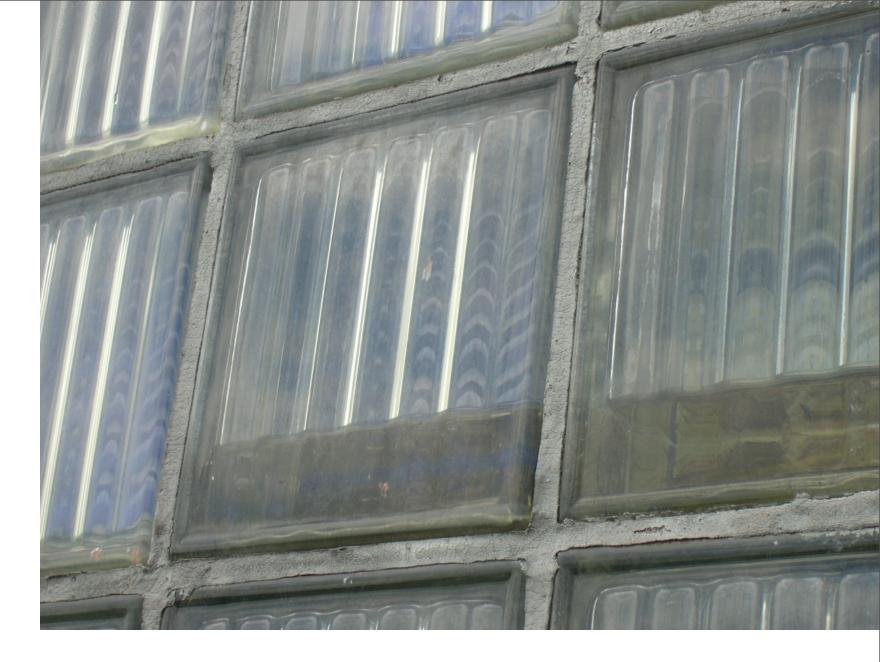
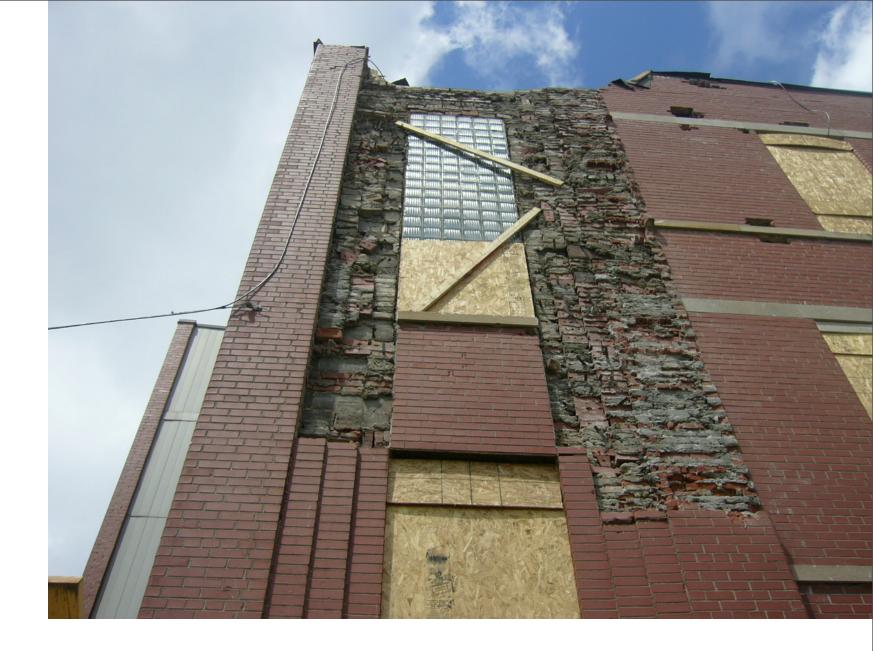
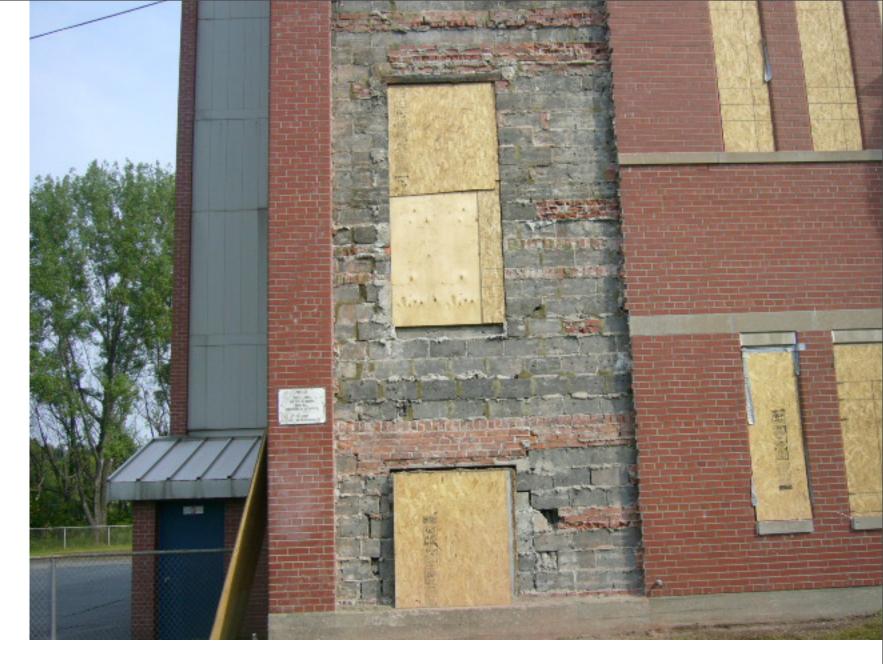
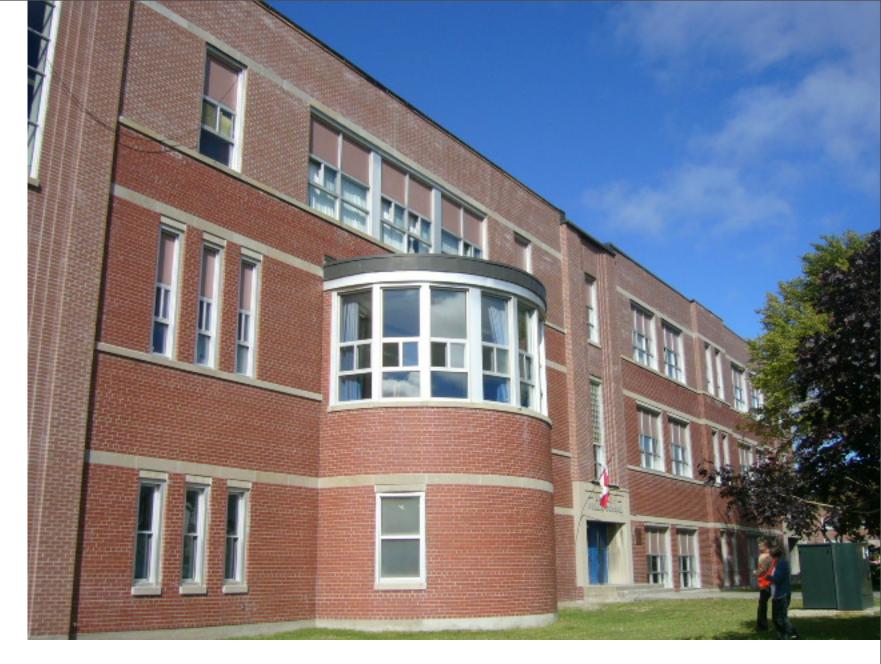
- no rain screen water that was getting into the wall, could not drain, would fill glass block and cause brick to spall, break apart, deteriorate
- no vapour barrier warm air passing through the exterior wall can contribute moisture to the exterior wall and cause brick to spall, break apart
- no insulation value at the exterior wall
- deterioration of the brick, glass block, parapet
- low quality masonry construction

- apply a new cladding to the exterior wall to provide a rainscreen
- install a new continuous vapour barrier
- add insulation to the exterior wall (R30+/-)
- repair deteriorated brick masonry
- upgrade windows, locate new windows to inline with new insulation at exterior wall
